# PADANARAM RESERVOIR DAM CT 00067

## PHASE I INSPECTION REPORT NATIONAL DAM INSPECTION PROGRAM

JULY 1980

Identification Number:	CT 00067
Name:	Padanaram Reservoir Dam
Town:	Danbury
County and State:	Fairfield County, Connecticut
Stream:	Padanaram Brook
Date of Inspection:	April 21, 1980

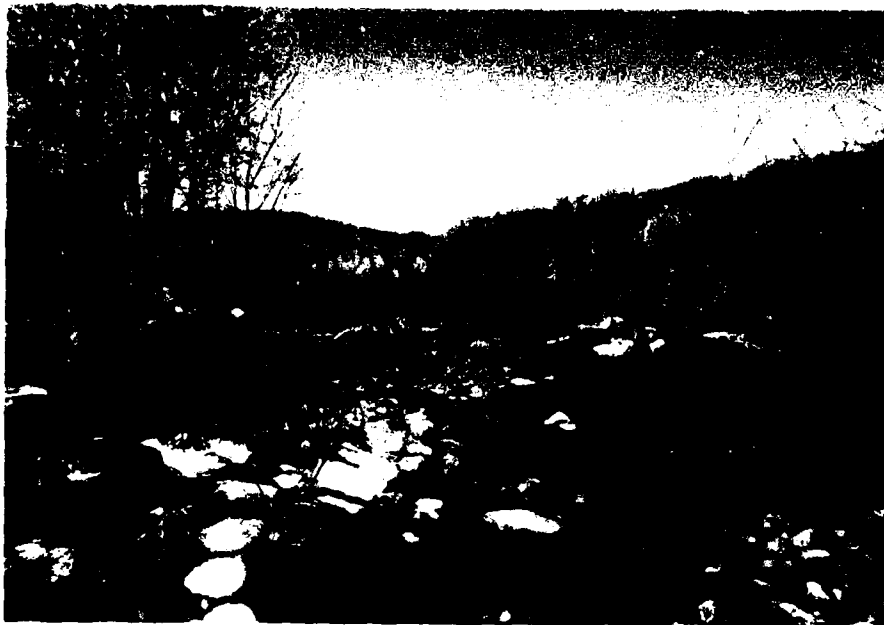
The spillway is a stone weir that is in fair condition (Photo 3). The approach channel is not well defined and is the natural slope of the bottom of the pond. The training walls of the spillway are also stone masonry and are in fair condition. The downstream channel is a natural channel with riprap in some areas. It is 24 feet wide with steep side slopes (Photo 4). The condition is good except for areas of the channel where debris is cluttered.

PHOTO 3  
SPILLWAY-UPSTREAM
